Port Hills Geotechnical Group
Assessment of GNS Model Applicability for Cliff Collapse Risk

Sector: 1 Address: 88 BULLOCK BAY

Port Hills Geotechnical Group
s124 (geo) Notice Decision Process - Cliff Collapse

Address of property: 1 BOULDER BAY

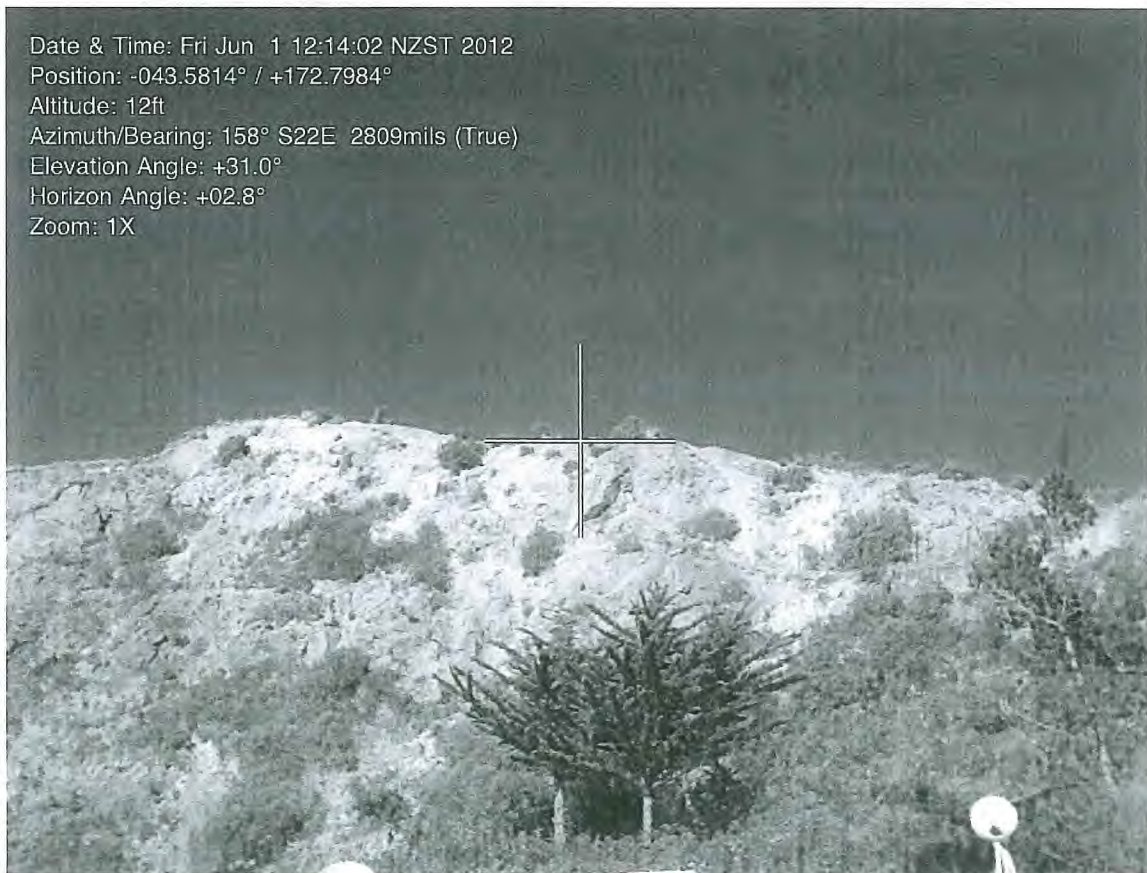
Date & Time: Fri Jun 1 12:14:02 NZST 2012
Position: -043.5814° / +172.7984°
Altitude: 12ft
Azimuth/Bearing: 158° S22E 2809mils (True)
Elevation Angle: +31.0°
Horizon Angle: +02.8°
Zoom: 1X

Is an S124 Notice Required?
 Yes No **ALREADY PLACED**
 Cannot make this assessment from available information

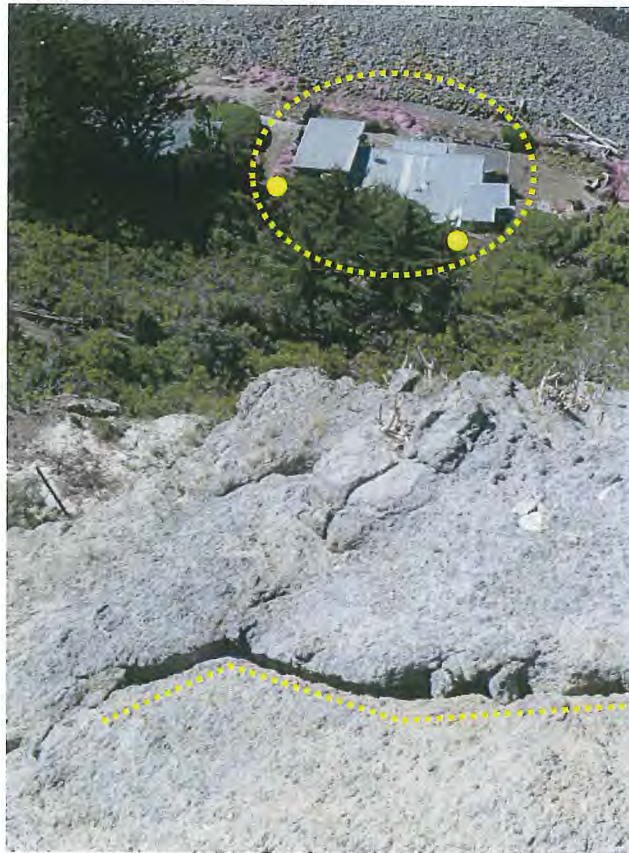
- The property at 1 Boulder Bay is situated at the base of a cliff.
- Portions of the cliff adjacent to the dwelling collapsed as a result of both the 22 Feb and 13 June 2011 aftershocks.
- At least two boulders fell from the cliff and landed within 10m of the dwelling
- Several small collapses of the cliff face behind the house were observed following the 22 Feb and 13 June 2011 aftershocks.
- Tension cracks are present on the cliff situated behind the property.
- There is a potential for further failure of the cliff in this area.

View from cliff top above 1 Boulder Bay (yellow dashed circle). A tension crack (yellow dashed line) is present near the cliff edge. Two boulders (yellow circles) landed near the dwelling following the 22 Feb aftershock.

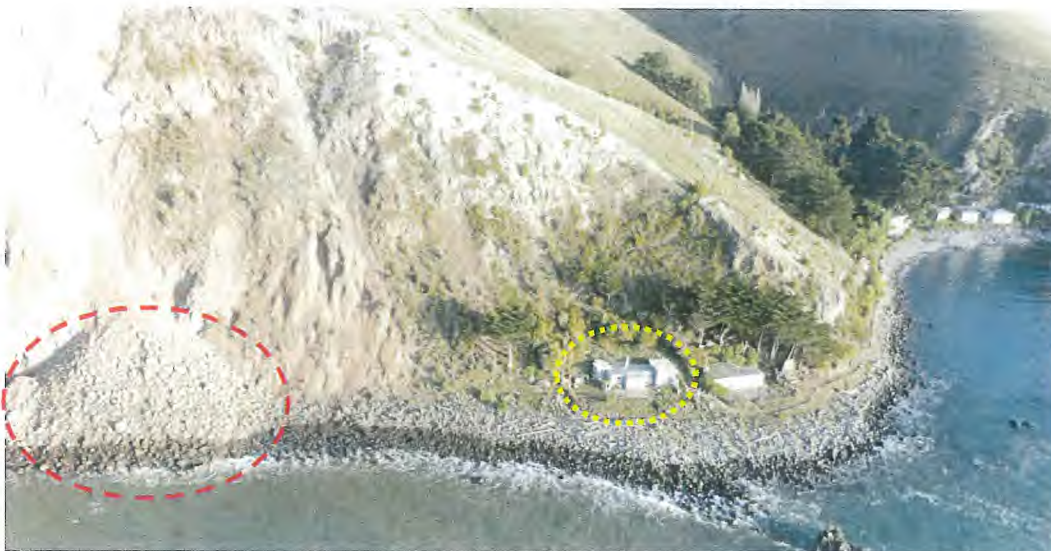
View of 1 Boulder Bay (yellow circle), showing debris from cliff collapse that occurred on 13 June, 2011 (red circle).

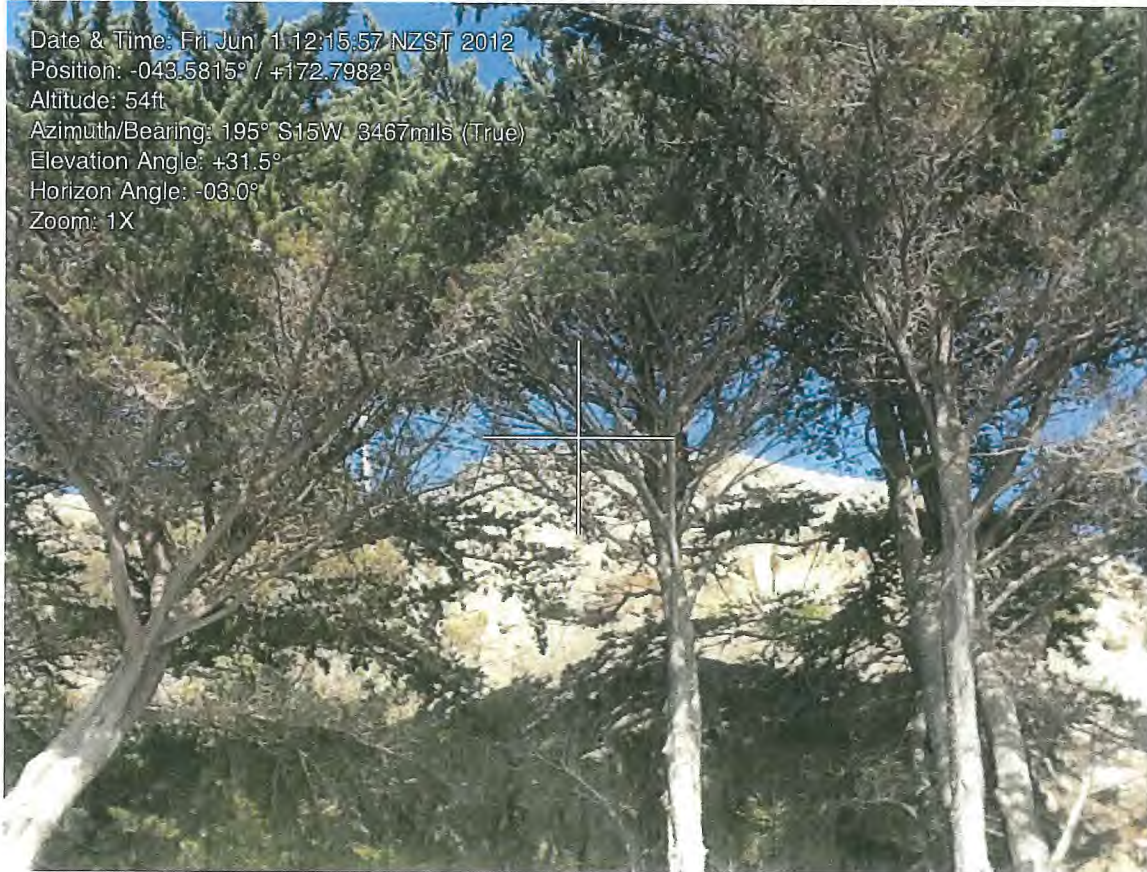
Date & Time: Fri Jun 1 12:15:57 NZST 2012
Position: -043.5815° / +172.7982°
Altitude: 54ft
Azimuth/Bearing: 195° S15W 3467mils (True)
Elevation Angle: +31.5°
Horizon Angle: -03.0°
Zoom: 1X

Comments:
S124 in place already
tension crack at cliff crest
