**Port Hills Geotechnical Group
Assessment of GNS Model Applicability for Cliff Collapse Risk**

Sector: 1 Address: 88 BULLOCK BAY

Port Hills Geotechnical Group
s124 (geo) Notice Decision Process - Cliff Collapse

Address of property: 1 BOULDER BAY

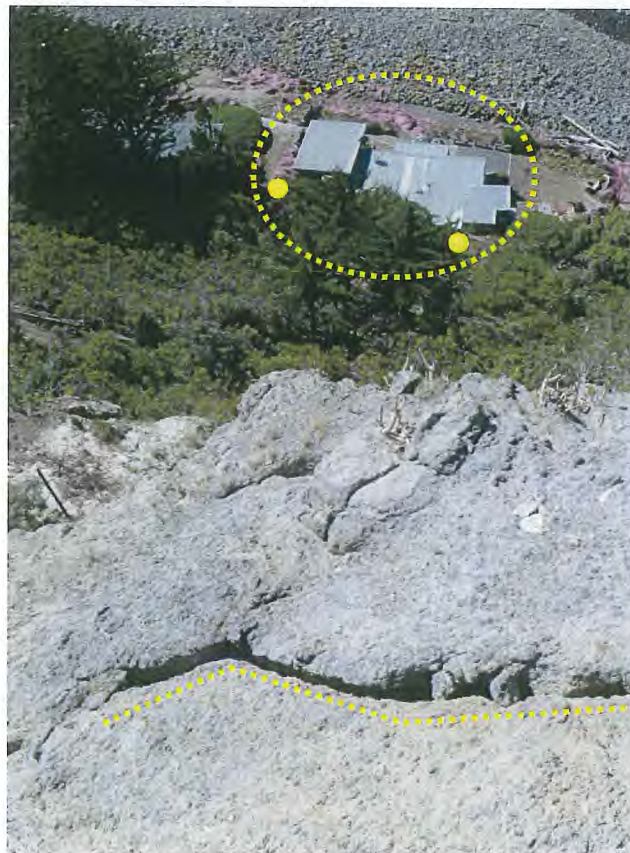
- The property at 1 Boulder Bay is situated at the base of a cliff.
- Portions of the cliff adjacent to the dwelling collapsed as a result of both the 22 Feb and 13 June 2011 aftershocks.
- At least two boulders fell from the cliff and landed within 10m of the dwelling
- Several small collapses of the cliff face behind the house were observed following the 22 Feb and 13 June 2011 aftershocks.
- Tension cracks are present on the cliff situated behind the property.
- There is a potential for further failure of the cliff in this area.

View from cliff top above 1 Boulder Bay (yellow dashed circle). A tension crack (yellow dashed line) is present near the cliff edge. Two boulders (yellow circles) landed near the dwelling following the 22 Feb aftershock.

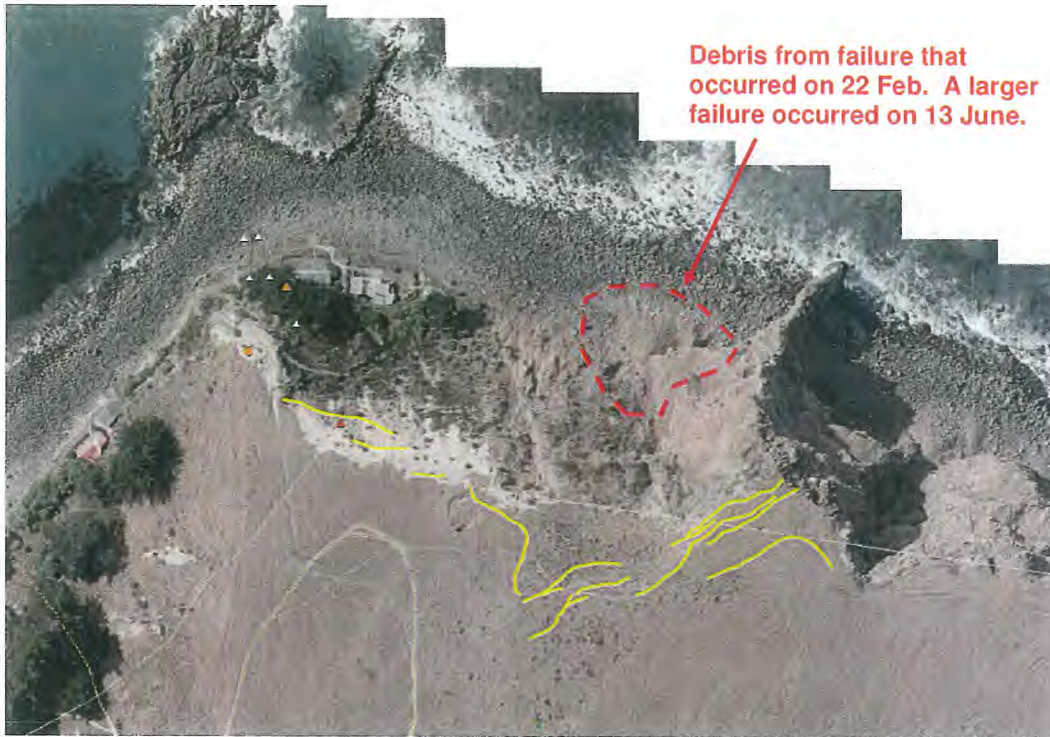
Map of tension cracks (yellow lines) on slopes above Boulder Bay. Tension cracks were originally mapped in late October 2011. Aerial photo is from late February 2011.

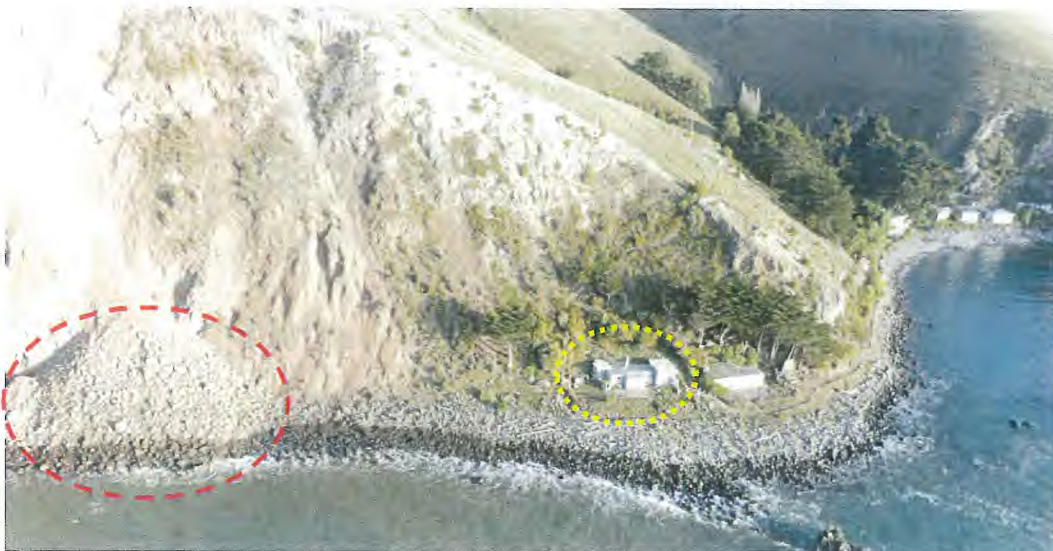
View of 1 Boulder Bay (yellow circle), showing debris from cliff collapse that occurred on 13 June, 2011 (red circle).
