Port Hills Geotechnical Group
Assessment of GNS Model Applicability for Cliff Collapse Risk

Sector: 1 Address: 88 BULLOCK BAY

Port Hills Geotechnical Group
s124 (geo) Notice Decision Process - Cliff Collapse

Address of property: 1 BOULDER BAY

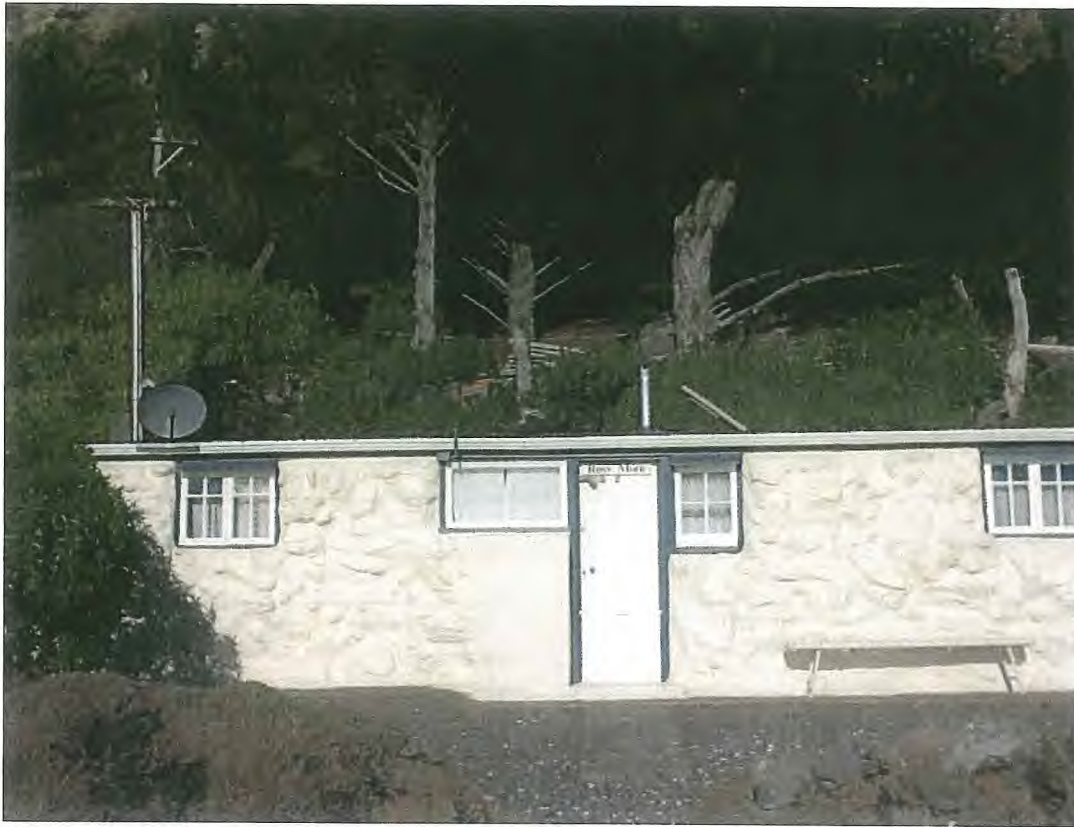
Date & Time: Fri Jun 1 12:15:57 NZST 2012
Position: -043.5815° / +172.7982°
Altitude: 54ft
Azimuth/Bearing: 195° S15W 3467mils (True)
Elevation Angle: +31.5°
Horizon Angle: -03.0°
Zoom: 1X

Comments:
S124 in place already
tension crack at cliff crest
